Case Study: The MediaWorks, White City

The project

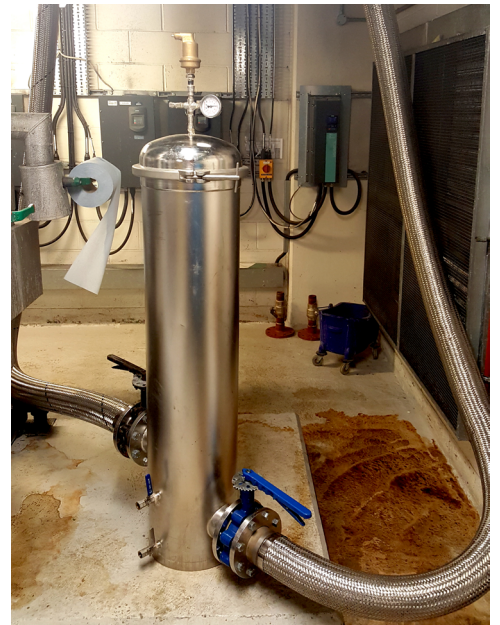
Following routine sampling of The MediaWorks' Chilled Water (CHW) system, high levels of Pseudomonas were identified, forming layers of biofilm on the surfaces of the pipework and plate heat exchangers. If left, this biofilm would lead to corrosion.

Apart from the Pseudomonas, overall the CHW system chemistry was stable; particularly in terms of total and dissolved iron and copper levels. Traditionally, biofilm is dealt with using flushing, which in itself can cause issues. During the flushing process, large quantities of fresh water containing dissolved oxygen are introduced to the system, which will increase the corrosion rates of these metal components.

As an alternative solution, Guardian used in-line filtration, which removes the need for flushing, therefore retaining the stable chemistry of the system and preventing water wastage. Commonly, filtration takes place on a smaller side stream pipe, with water diverted through it. With in-line filtration, larger filters are placed on the main pipework, allowing more debris to be caught and less chance of blockage.

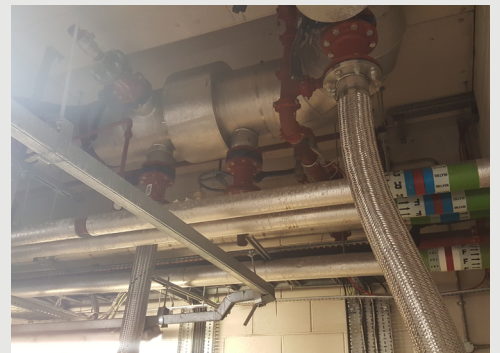
Using in-line filtration, existing water is retained in the system, eliminating chemical and water wastage. The in-line filtration system can also be left in place temporarily whilst fit out works are carried out, to ensure water quality is maintained throughout the process.
